High-Speed Video Observations of Downward Negative Lightning Attachment to Tall Structures at the Kennedy Space Center

Abstract

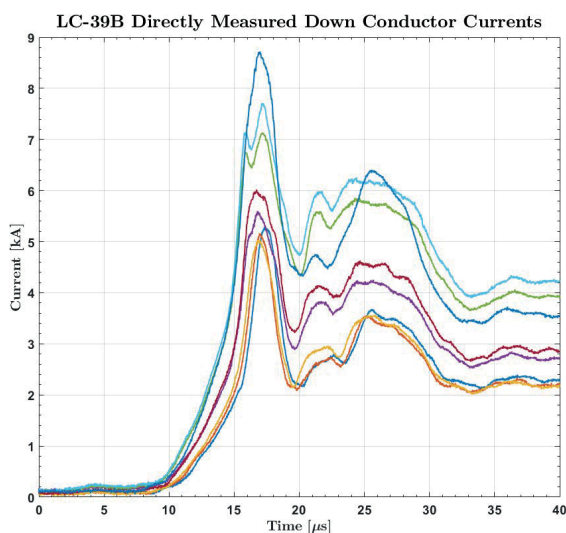
Figure 4 Directly-measured LC-39B down-conductor current waveforms.

leader propagation. The downward stepped leader propagated in a highly branched manner. In response to the downward stepped leader, two long sustained upward connecting positive leaders (UCPLs) were launched from the vicinity of Tower 2 and Tower 3, while a third upward positive leader (UPL) was launched from the vicinity of Tower 1 (Figure 3, Frame -3). The upward leaders are labeled L1, L2, and L3 in Figure 3, corresponding to their general origination points at Tower 1, Tower 2, and Tower 3 (see Figure 2). At the end of the Frame -3, which ended about 136 μ s prior to the attachment, L1, L2, and L3 had 2D lengths of about 106 m, 218 m, and 116 m, respectively. Leaders L2 and L3 both connected to different branches of the downward leader within a time period of a couple microseconds (Figure 3, Frame 0). The return stroke current due to the nearly simultaneous attachment points was directly measured at ground level on all nine LC-39B down conductors. The current waveforms are plotted in Figure 4 on a 40 μ s timescale. The sum of the peak down conductor current waveforms totaled about -55.5 kA.
