Lightning Damage to Residences, A Guide to Homeowners

Dr. Carlos Mata^a and Dr. Dustin Hill^a

^aScientific Lightning Solutions, LLC, Merritt Island FL, USA

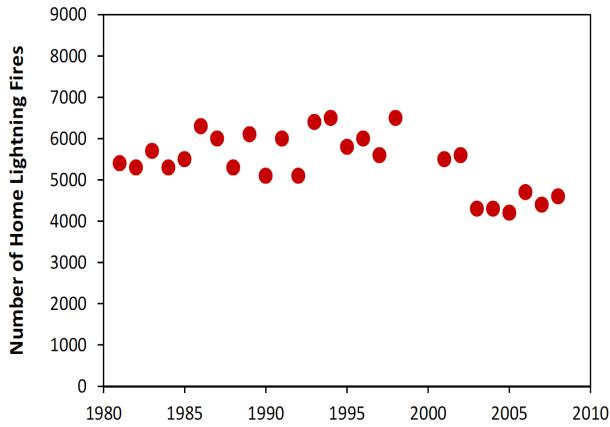
Figure 1 Number of home fires caused by lightning in the United States from 1980 to 2010, adapted from [5].

The intense heat from a lightning strike can ignite building materials, creating fire hazards, especially if it strikes wooden components or flammable substances. Damage to wiring insulation can lead to high impedance faults, potentially igniting materials hours, days, or weeks after the strike (see Figure 1).
